**ARCHITECTURE OF THE POPHAM COLONY, 1607-1608:**

**AN ARCHAEOLOGICAL PORTRAIT OF ENGLISH**

**BUILDING PRACTICE AT THE MOMENT**

**OF SETTLEMENT**

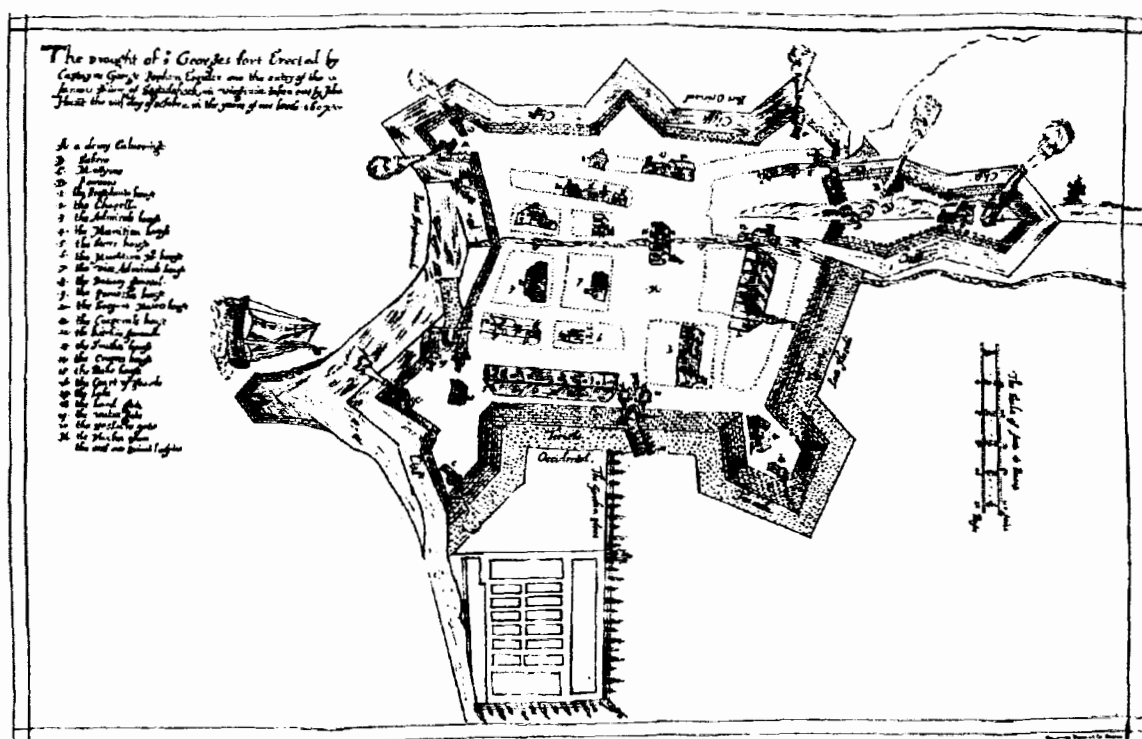
Figure 2. Brought to light at the General Archives of Simancas, Spain in 1888, this map was drawn by John Hunt in October 1607. The inscription in the upper left reads: "The Draught of St. Georges fort Erected by Captayne George Popham Esquire on the entry of the famous River of Sagadahock, in Virginia taken out by John Hunt the viiith day of october in the yeare of our lord 1607" (From Henry O. Thayer's copy, Maine Historical Society).

Unlike the contemporary settlement at Jamestown, for which there is no detailed plan, Fort St. George is depicted in detail in a contemporary map prepared by John Hunt (Figure 2). Clearly Hunt was present at Fort St. George and presumably the colony's leaders recruited him in part for the cartographic skills attested by his map. Aside from his name on the map, however, no mention of him has been found either in the colony's records or elsewhere.<sup>15</sup> Still, the quality of his work shows that he was trained in much the same tradition as the more famous French explorer and navigator Samuel Champlain or English surveyor Thomas Raven, known for his careful renderings of England's Ulster plantations in the 1620s.<sup>16</sup> Though skilled, the level of drafting that these men demonstrated was not so demanding as to represent a distinct trade in itself. Instead, this kind of record keeping was a useful peripheral skill to any number of occupations, including: navigation, surveying, military or civil engineering, house construction, architecture, espionage, or exploration. The colony's leadership might have recruited

Hunt completed his map on October 8th, 1607, in time to ship it on *Mary and John*, which sailed two days later. The ship carried the map to England, but within a year, Don Pedro Zuñiga, Spanish ambassador to England, appropriated it. Zuñiga forwarded it and other documents concerning Virginia, along with a cover letter dated September 10, 1608, to King Philip III of Spain. Possibly this was the only copy of Hunt's map then in existence, as no copy of it has been found in England.<sup>17</sup>

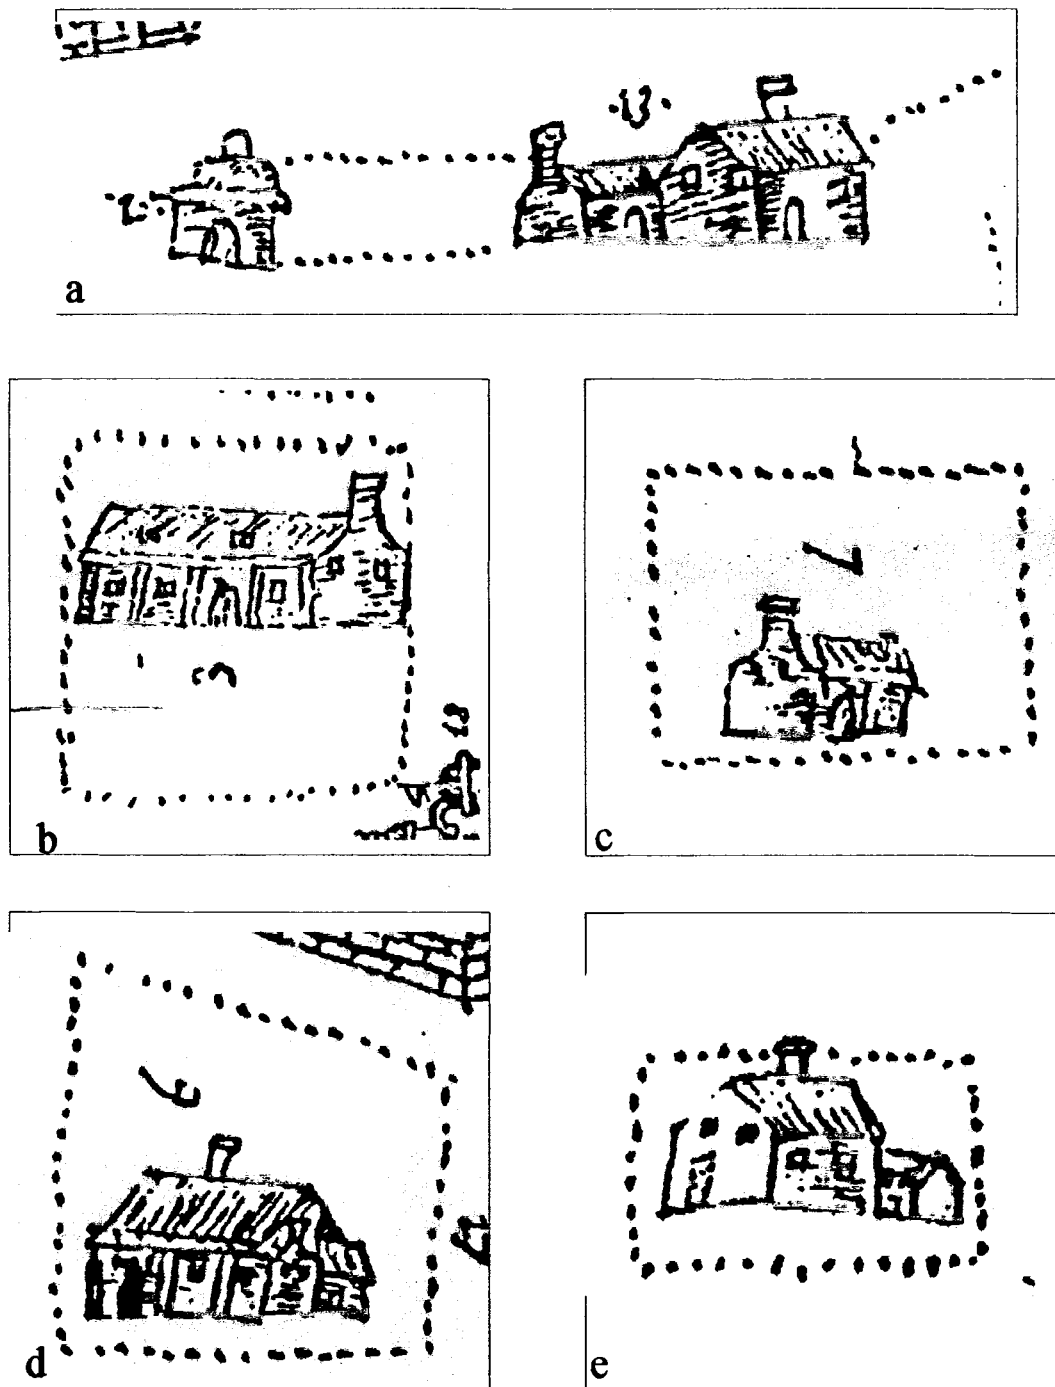
Figure 3. Details of selected dwellings at Fort St. George as illustrated by John Hunt. a. bake house and smith's house; b. Admiral's house; c. Vice Admiral's house; d. Provost's house; e. unidentified dwelling. B, c, and d were each timber framed, while construction of a and e is ambiguous. Note the variability in door and chimney placement.

In twelve buildings with chimneys, the stack stood centered at, and apparently interior to, the gable-end (see Figures 3a center, 3b, and 3c). In six instances, the chimney stood nearly-centered in the house (see figures 3a right, 3d, and 3e). In the remaining four instances, the location of the chimney appears ambiguous. The location of the door in relation to the chimney is not always apparent, but it can be discerned in a few instances. In the Admiral's house, a four bay long structure, the chimney is at the end of the house

and the door in one of the middle bays (Figure 3b). The provost's house, possibly two bays in length, has a center chimney, and a door in the sidewall at one end (Figure 3d). It is not clear whether this building had an entrance lobby into the chimney space or not. The court of guards has its chimney at one end and its doorway at the opposite end (Figure 4c). This arrangement is also found in a neighboring unlabeled residence (Figure 2). The door of the smith's house appears centered in a sidewall, while its chimney is at the gable end (Figure 3a). The arrangement is nearly reversed in the building adjoining on the right, with its door offset to one end of the sidewall, but its chimney centered. Of the chimney-less buildings, the coopers house and buttery general have doors centered in their sidewalls; the munitions house has its door on the gable end but offset to one side, while the chapel (Figure 4b) and storehouse (Figure 4a) had doors on their sidewalls, offset to one side of center.

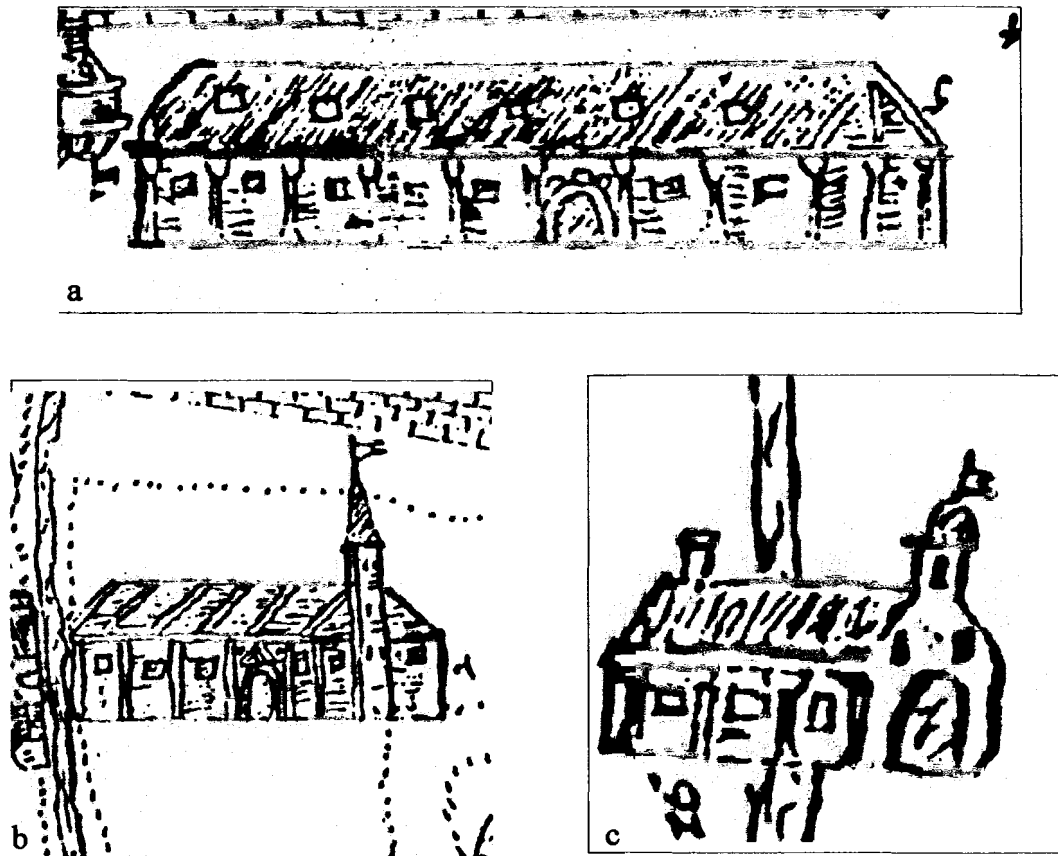
Figure 4. Details of selected public buildings at Fort St. George as illustrated by John Hunt. a. storehouse; b. Chapel; c. Court of Guard. Each of these major buildings was timber framed. Note the "dormers" in the storehouse roof and the steeple and cupola on the chapel and Court of Guards, respectively. Also, note the roofing detail shown on the chapel.

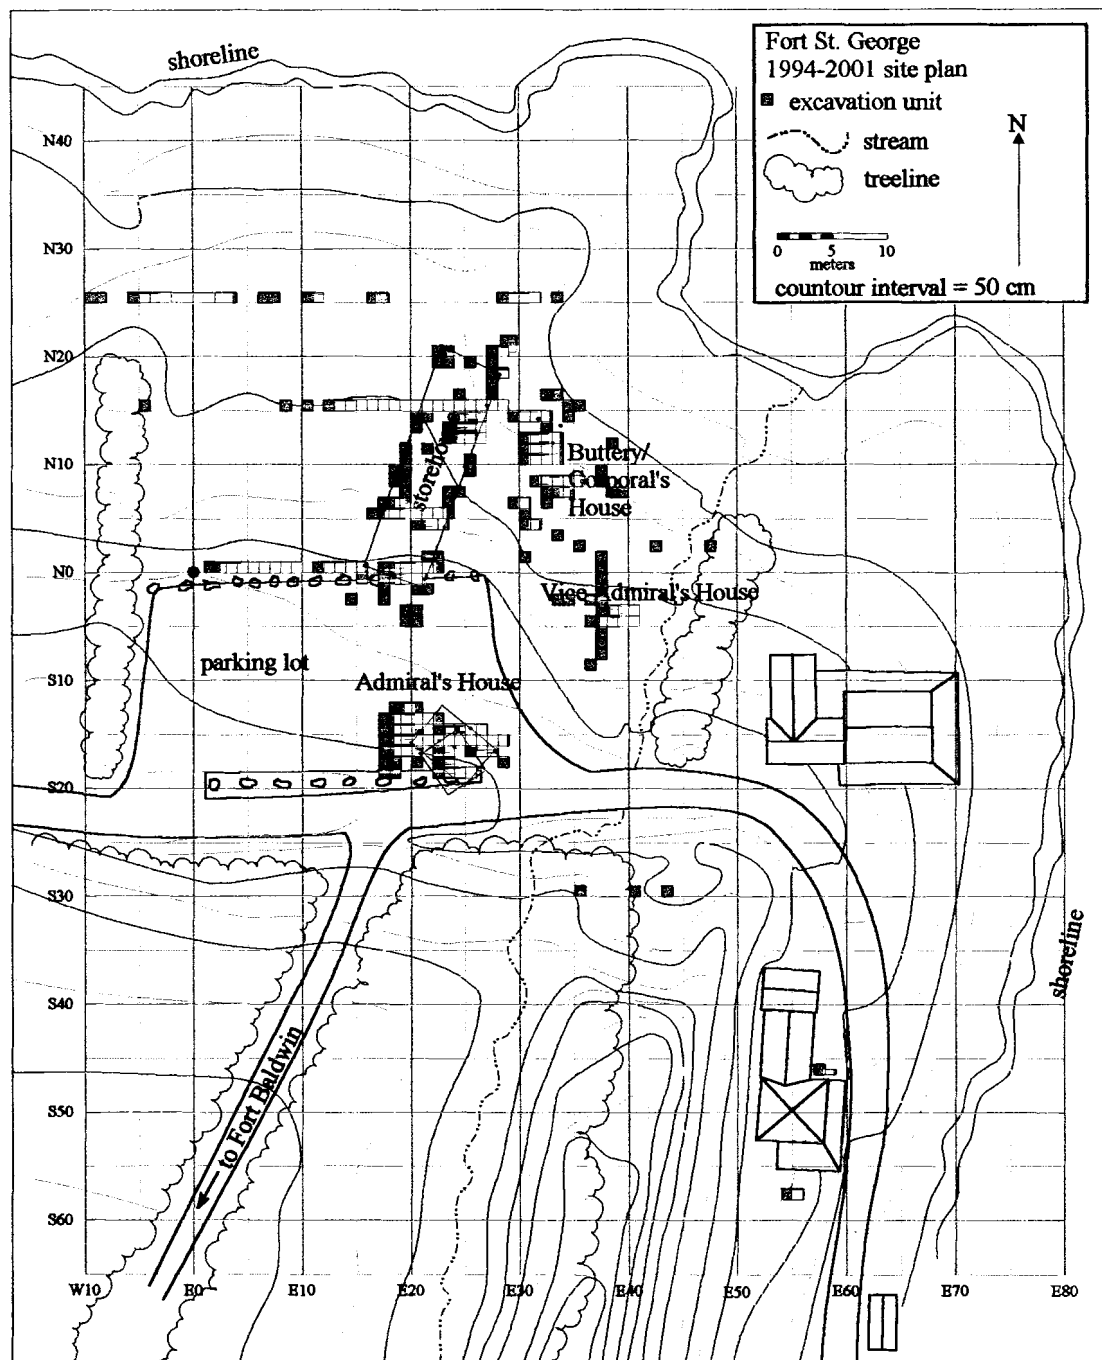
Figure 5. Hossketch Point in Popham Beach, Maine, site of the Fort St. George excavations, 1994-2001. The fort covered the parking lot, the lawn to the north, and the grounds of the two standing houses. The high bedrock ridge is the site of the fort's "citadel" as depicted by John Hunt's map of 1607. (Adapted from Jeffrey P. Brain, *Fort St. George*, p. 28, figure 17)

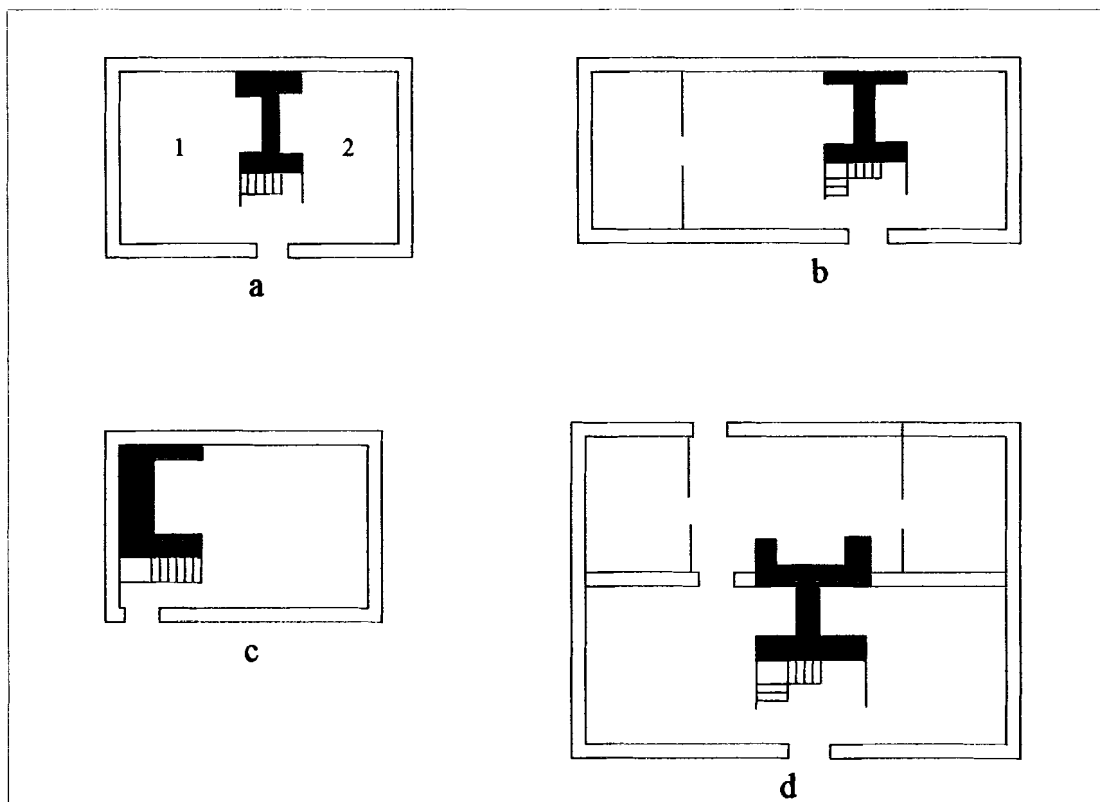
Figure 8. Typical "central fireplace" houses, common in lowland eastern England and in New England. The principal unifying characteristic of "central-chimney" houses is not the location of the chimney with respect to the floor plan, but with respect to the entrance lobby and stairs. In particular, the principal entrance is into a lobby adjacent to the chimney and not into the living-space of the house. (a) Basic plan with hall (1) and parlor (2) on ground floor. (b) Variant with additional rooms at one end. (c) One room variant. (d) Additional service rooms in rear. In New England, this floorplan is found in "salt-box" and Cape Cod houses. After R. W. Brunskill, page 107.

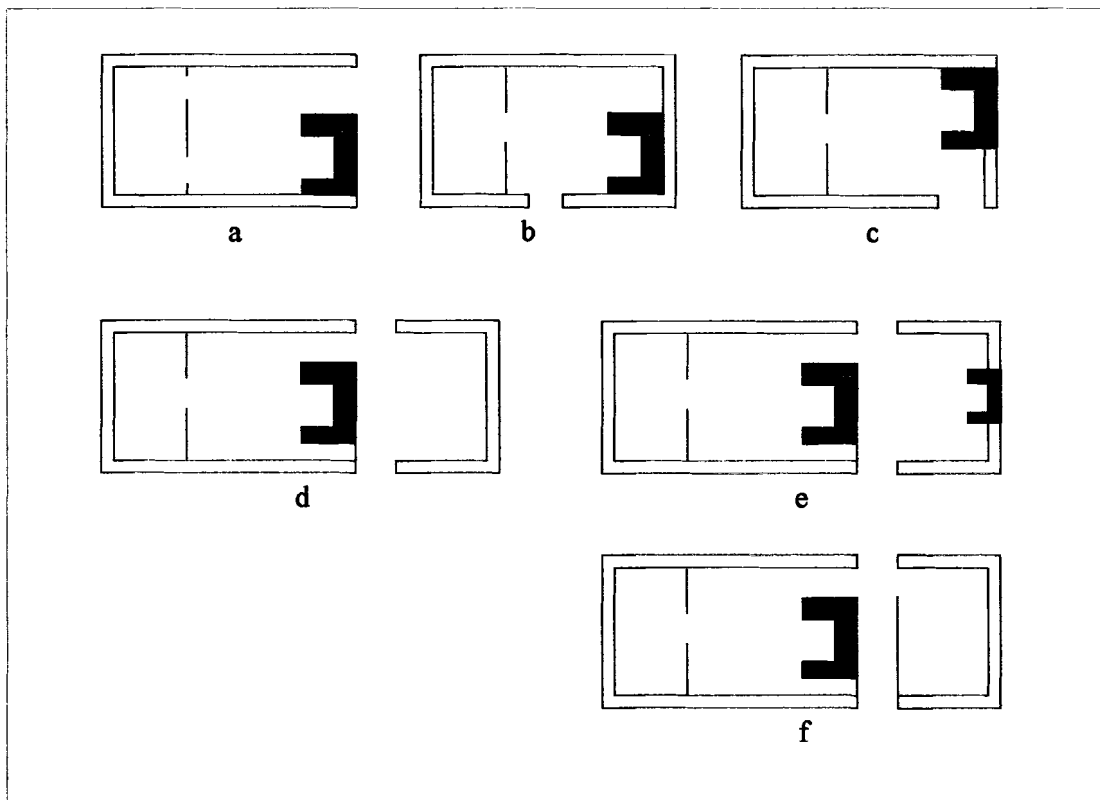
Figure 9. Typical two-cell houses, common in the western counties of England. The simplest form consists of a single structural unit separated into two rooms by a partition. The main room was heated by an end-fireplace. The principal entrance usually was directly into the main living-space of the house rather than into a separate lobby. The essential trait is a partitioned single structural cell with (a) Basic plan. (b) Alternative door placement. (c). Alternative fireplace and door placement. This arrangement converges in form with the central fireplace group of houses (see Figure 8 c). (d) Variant with cross passage and service room added at lower end. (e) Extended version with fireplace for additional living space. (f). "Longhouse:" additional room is partitioned to separate animal space (byre) from cross passage and living space. After R. W. Brunskill, page 105.

The "two-unit" family of houses is subtly different in plan. The simplest form consists of a single structural unit separated into two rooms by a partition (Figure 9 a, b, c). The main room was heated by an end-fireplace. The principal entrance usually was directly into the main living-space of the house rather than into a separate lobby.<sup>41</sup>

In extended versions of the two-unit house, an additional room was placed beyond the main fireplace (Figure 9 d, e, f). In this case, the entrance would be situated in such a way that the continuous straight-line passage to a second door at the rear of the house was maintained, forming a cross-passage. If it was to be used as living-space, the added room could have its own fireplace (Figure 9 e). In this case, the additional fireplace also had its

own chimney.<sup>42</sup> If the additional space was to be used as a byre, or cow barn, a second chimney was not needed. This form is known either as a byre house or a "longhouse" (Figure 9 f).<sup>43</sup>

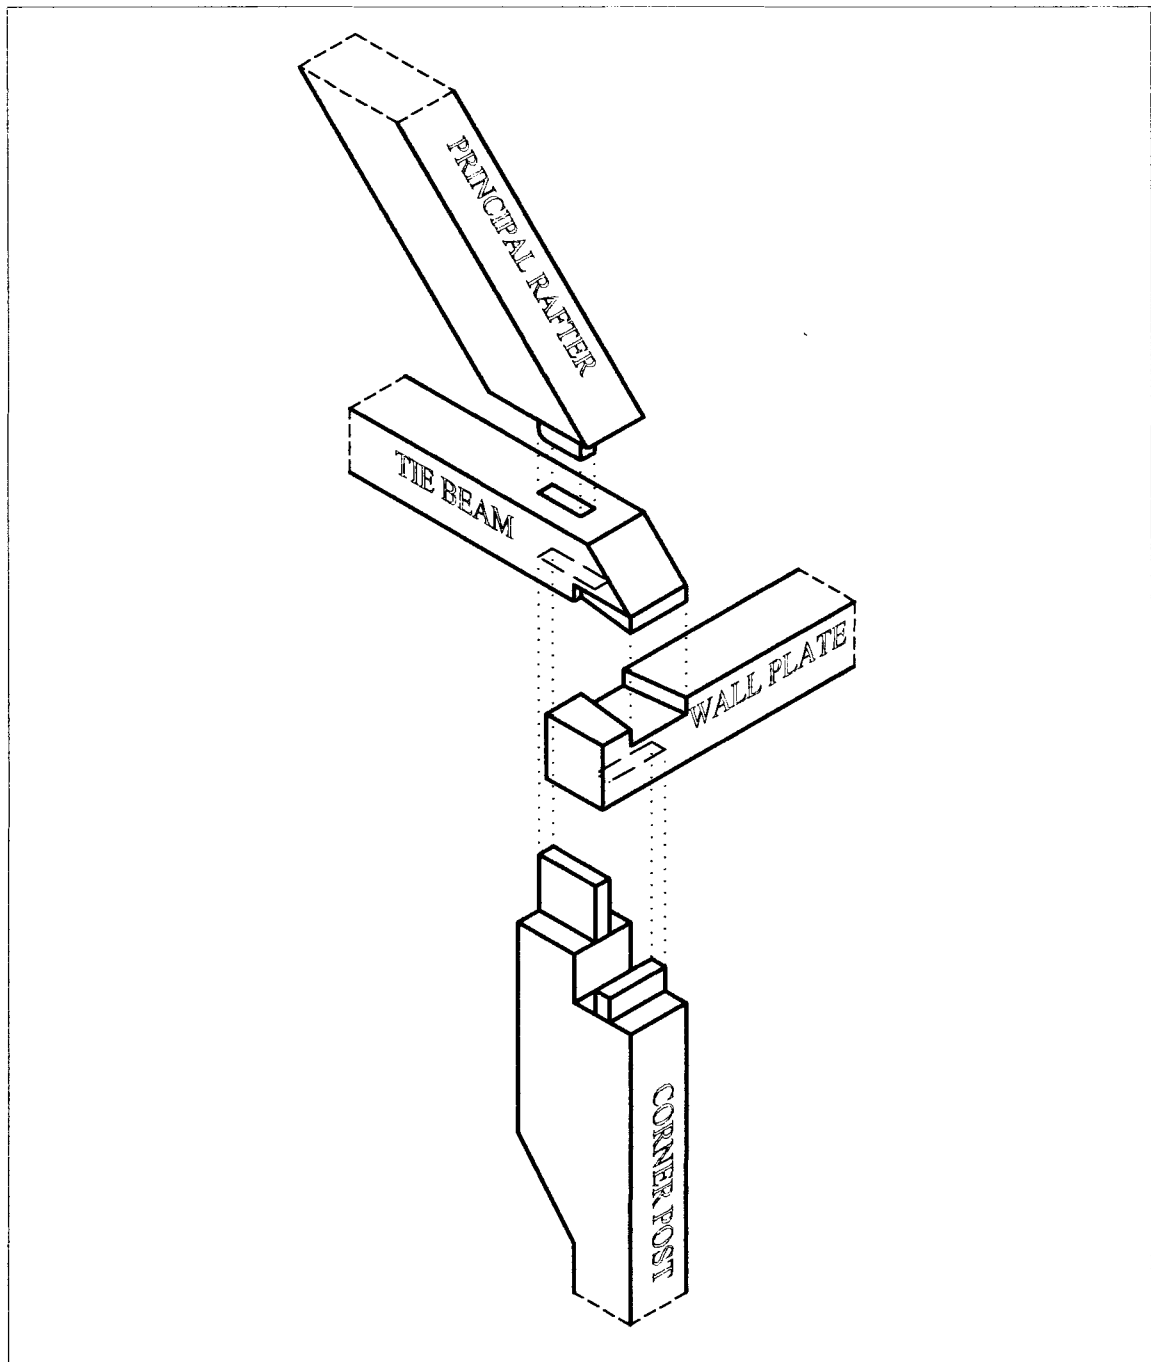
Figure 10. Typical joinery used to connect post, wall plate, tie beam, and rafter in normally assembled buildings. Compare to Figure 11.

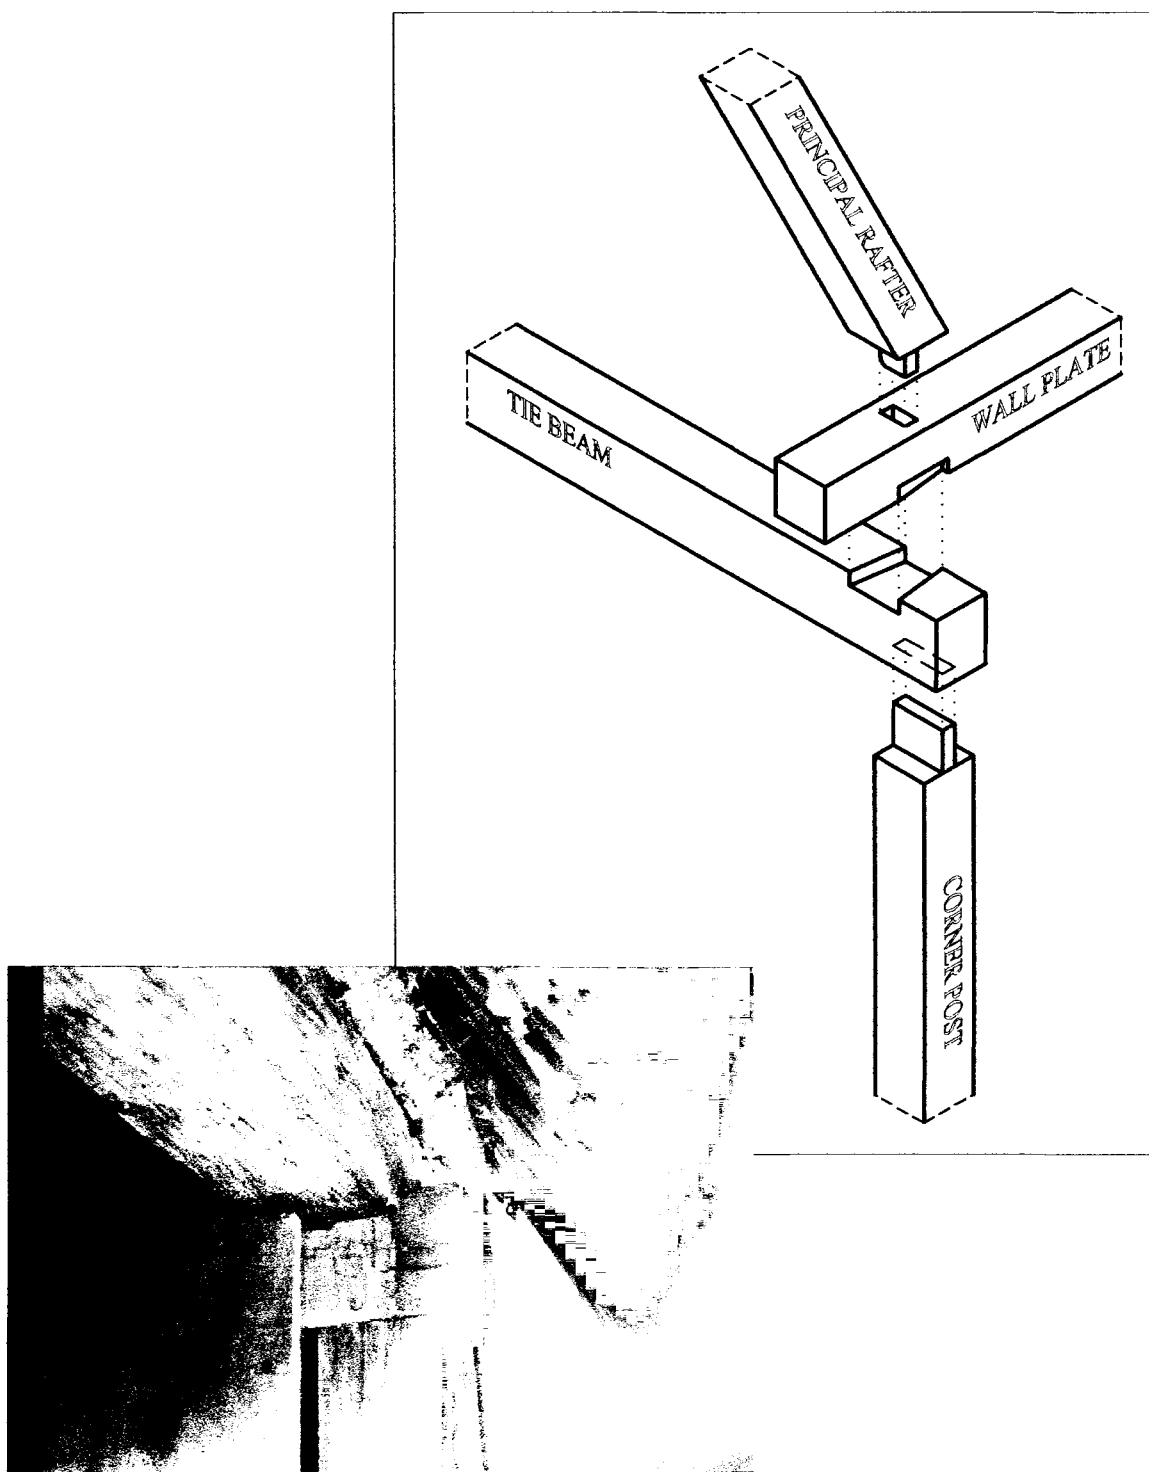
Figure 11. Conjectural joinery used to connect post, tie beam, wall plate, and rafter in single-story reverse assembled buildings. Inset: reverse frame joinery as used at Plimouth Plantation, Plymouth, Massachusetts.

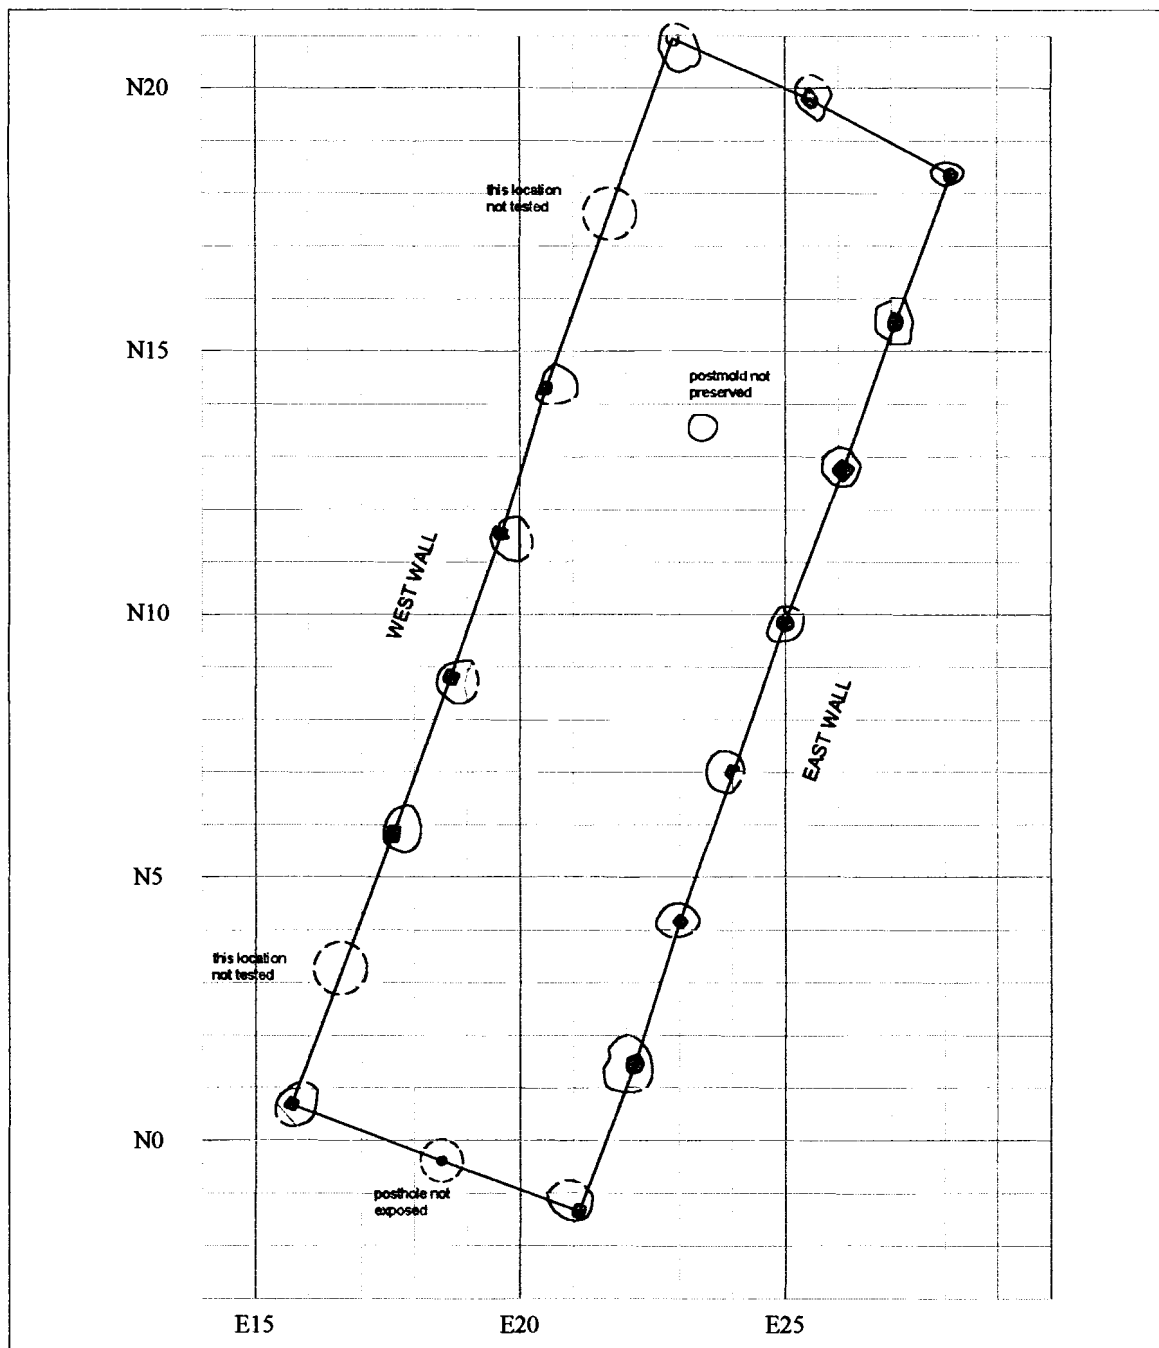
Figure 12. Spatial relationship between postmolds and postholes from the storehouse. Note that the east- and west-wall postmolds are located on the exterior or "outboard" side of the hole. Since a post base typically settles on the opposite side of a hole from where it is raised, this positioning indicates that storehouse posts were raised from the interior of the buildings footprint. The consistent pattern further suggests the posts were raised in assembled longitudinal wall sections, though the pattern could also be created by raising the posts individually from the building interior. The same relative positioning of postmolds and post molds would be unlikely in a building raised in transverse bent-sections.

The near perfect alignment of postmolds marking each wall line indicates that the storehouse was raised in pre-assembled side-wall sections. In other words, the builders used “normal” assembly. Because the storehouse was built in sidewall sections, we can further conclude that the wall plates were placed on top of the posts, and the tie-beams on top of the plates. The consistent placement of the wall posts against the outside of the holes permits us to go further, as this indicates the manner in which the posts were raised. When a builder raises a post, he first lays the post on the ground, its base over-hanging the

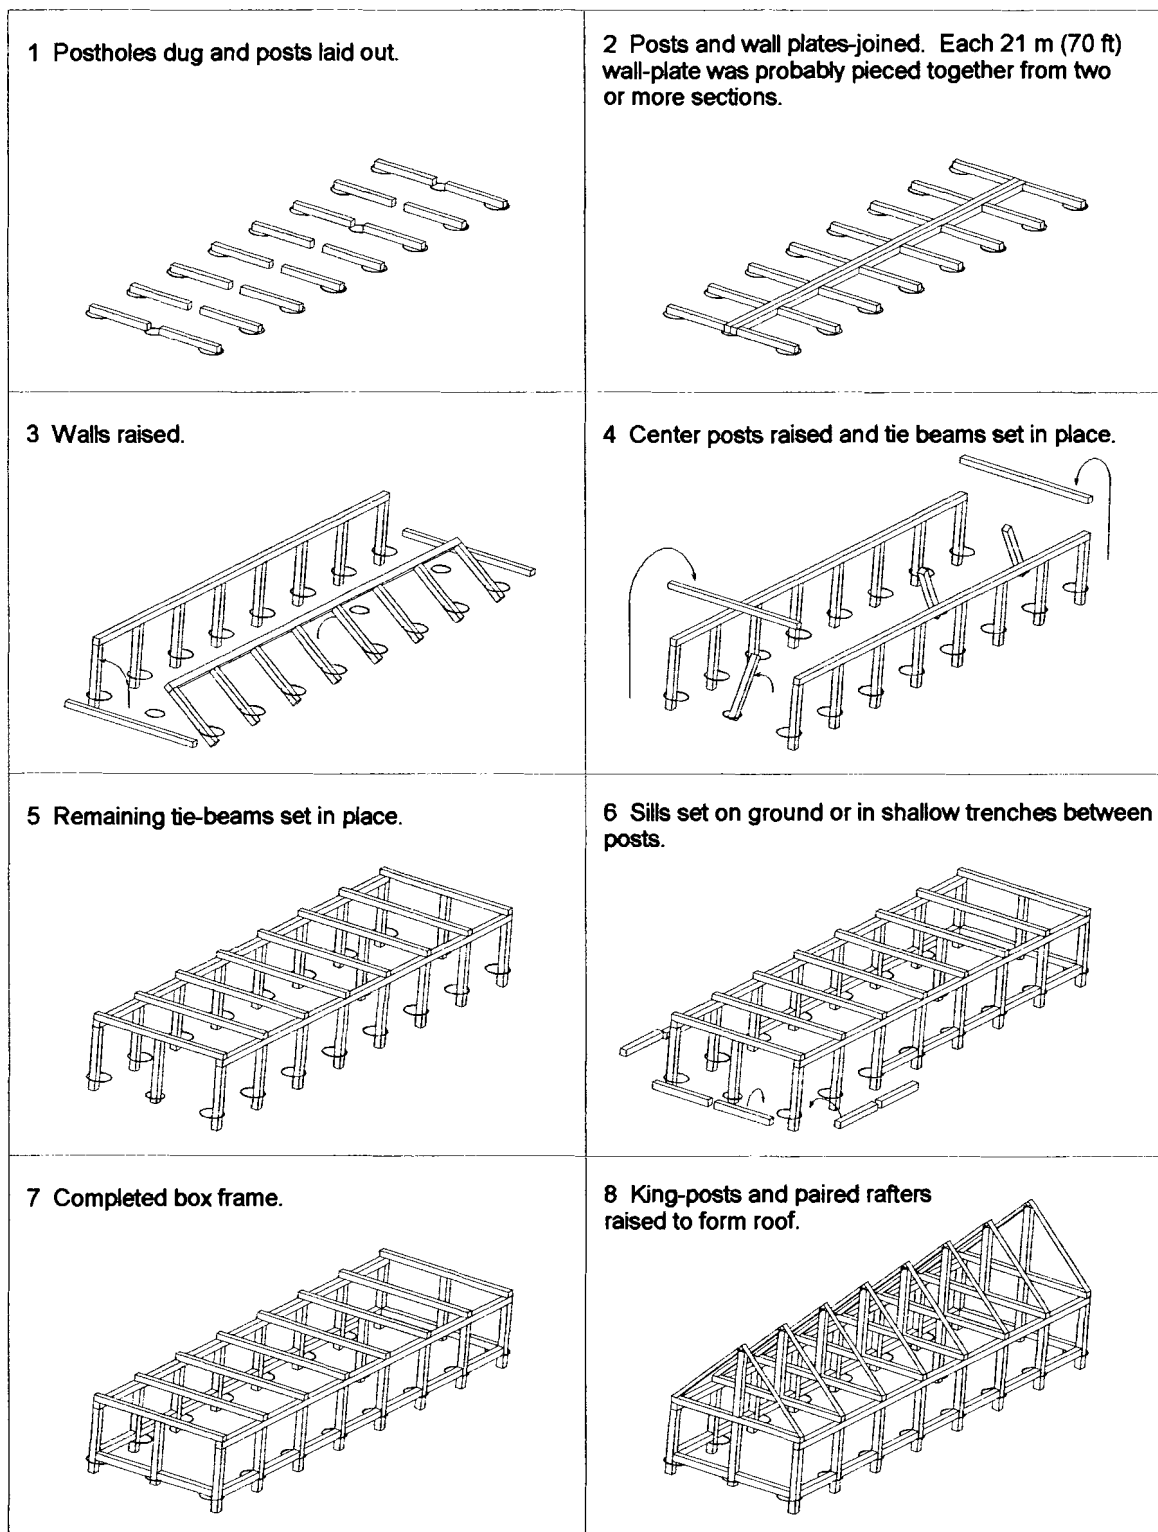
Figure 13. Assembly of major timbers in storehouse frame. Steps 1 through 7 are conjectured from archaeological data. The use of king posts with each pair of rafters in the roof, step 8, is a conjecture based on Hunt (see figure 2).

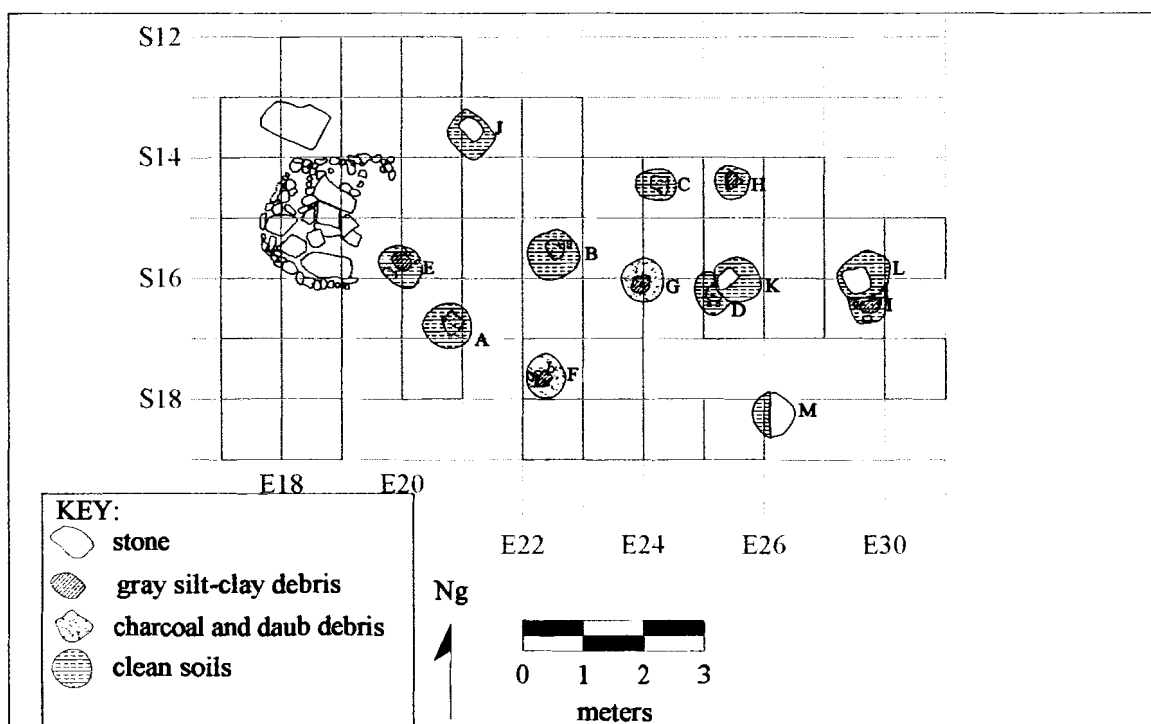
Figure 14. Hearth, postholes, postmolds, and large stones on the site of the Admiral's house. (After Jeffrey Brain, Fort St. George V, p. 8, figure 9.)

In the predicted location of the Admiral's house, Brain's team discovered nine posthole/postmolds, a half-excavated posthole in which a mold was not found, a hearth, and two separate debris fields. In addition to these, they found three posthole-like features. Each of these features lacked a postmold but contained one large stone. These, too, may have been related to the construction of the Admiral's house. The stone base of the hearth consisted of large flat-lying and closely-fitted slabs of schist at its center (Figure 14). These were surrounded by a semi-circular arrangement of smaller stones. Around the whole arrangement was a narrow trench, again semi-circular in plan.

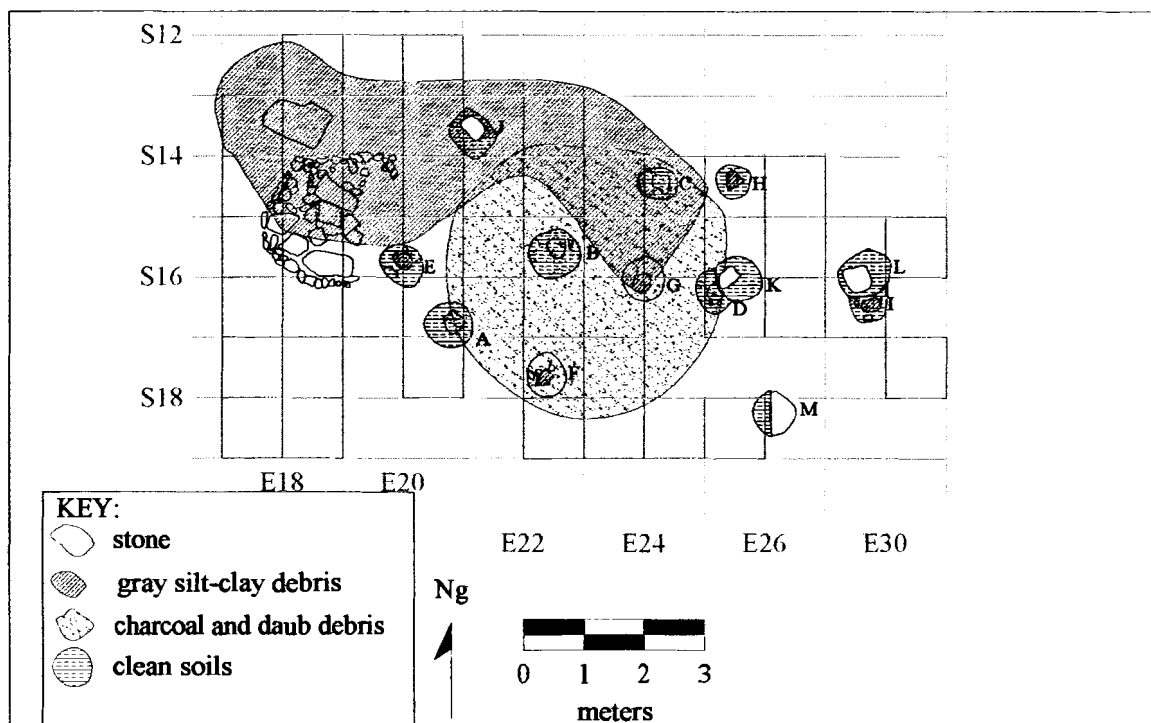
Figure 15. Extent of debris fields containing gray silty clay and fired daub and charcoal. (After Jeffrey Brain, Fort St. George V, p. 5, figure 4.)

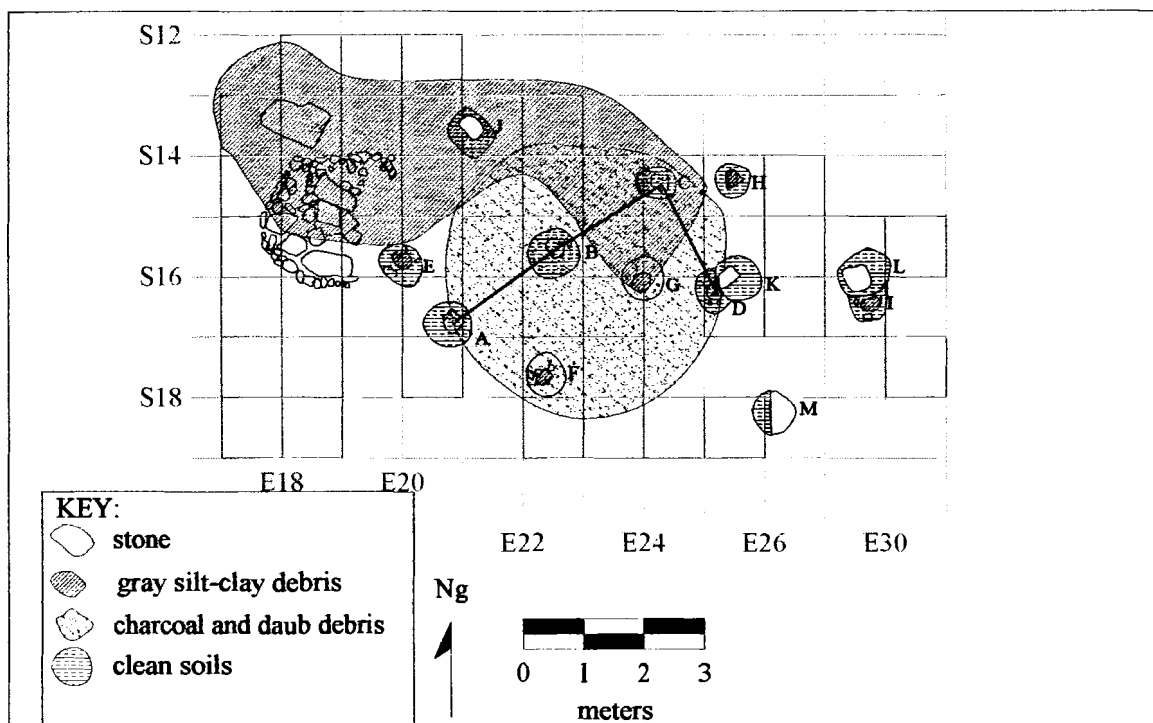
Figure 16. Features representing Raleigh Gilbert's first house. Each posthole was artifact- and debris-free; each postmold contained artifacts charcoal, and fired daub.

From these alignments, I believe that posts A, B, C, and D can be connected to show a partial outline of one structure. This was the *first* Admiral's house. Possibly, it was begun prior to October 1607 in time for John Hunt to have seen and drawn it. This building burned sometime during the course of the next year. The debris from its demolition fell primarily within the building's footprint forming the charcoal and daub-bearing debris field and filling the voids left by the building's burned-out posts. Thus, the distribution of debris consisting of the fired daub and charcoal correlates with the footprint

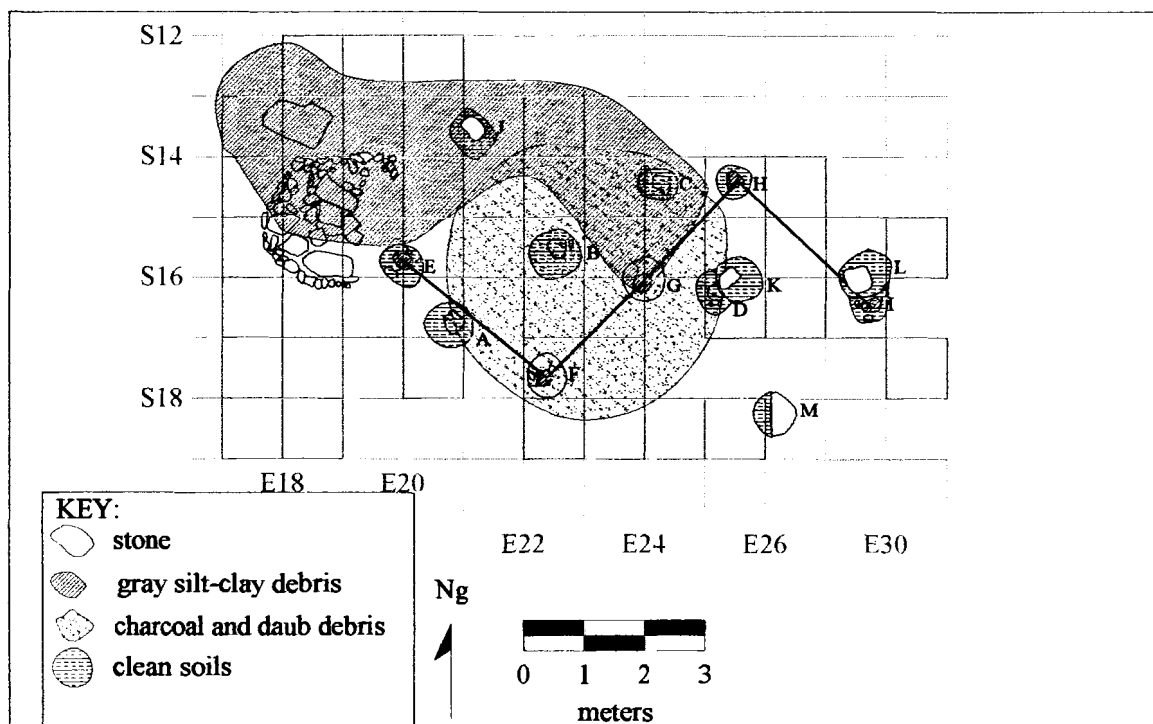
Figure 17. Raleigh Gilbert's second house. Postmolds contained humic soils and gray silty clay (unfired daub) and few artifacts. Postholes F and G contained burning debris from the first house. Postholes E, H, and I contained little burning debris and few artifacts.

Posts F, G, and H form a similar line. Here, the distances are not quite equal: from F to G is 2.14 meters while the distance from G to H 2.44 m. Two other posts are situated at nearly 90° to the FGH line. Post E lies 3.01 meters to the northwest of F (95° off the line), while post I lies 3.08 meters to the southeast of H (90° off the line). This pattern is made up of two different kinds of postholes-postmolds. Holes E, H, and I contain *nearly* artifact- and demolition-free sediments. The holes for posts F and G, on the other hand, contain large quantities of demolition debris and artifacts. All five of these features have similar molds, containing darkened soils, in some cases small amounts of decayed wood, and in each case, gray silty clay.

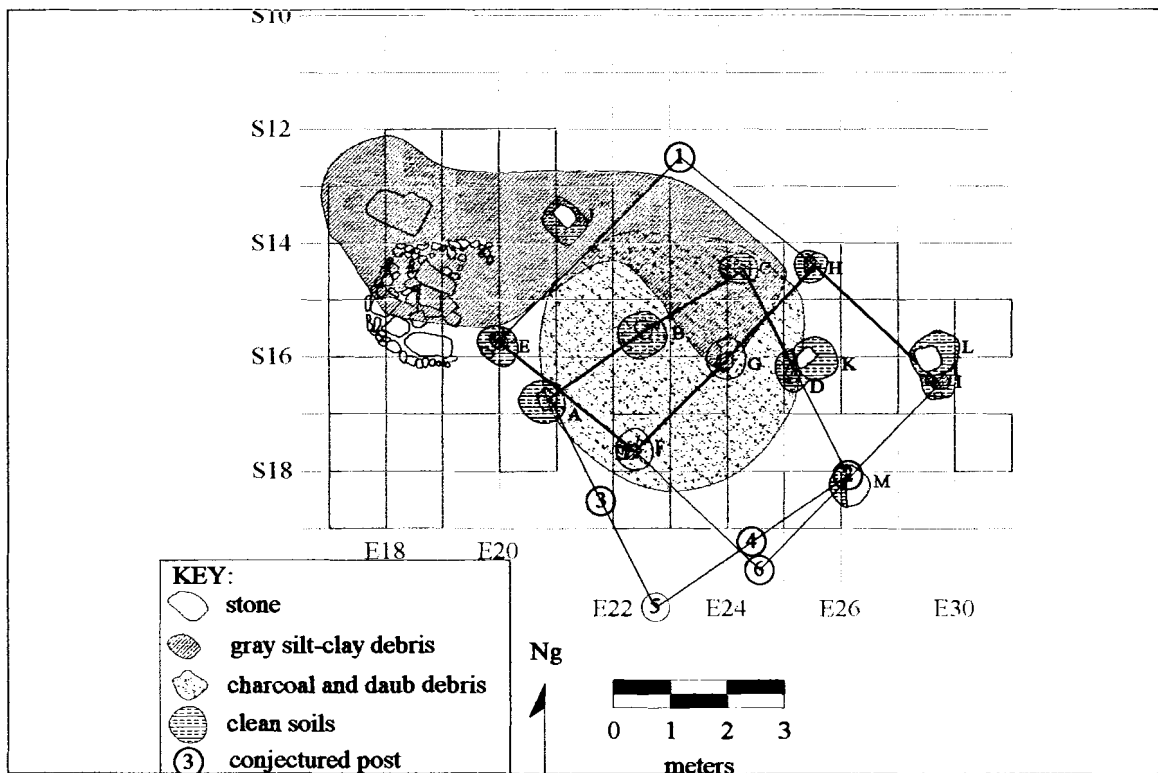
Figure 18. Possible location of additional postholes and postmolds related to Raleigh Gilbert's first and second houses.

A few well placed excavation units could confirm whether this scenario is correct. If it is correct, we can predict the likely location of additional postholes and postmolds (Figure 18) and it should be possible to predict what kind of material will be found in each, even before they are found. A predicted posthole at S12.5 E 23 (Figure 18 ①) should contain nearly sterile natural soils, perhaps with a little bit of daub and charcoal, and a postmold without debris. Location ② should mark the location of a posthole with natural soils, but with a mold full of debris. As a possible posthole with clean fill was already found at that location (Figure 18 M), the unexcavated portion of that hole might contain a debris-filled mold. However, this same location falls on the possible site of a posthole/postmold from the replacement structure. That being the case, there could be two postholes/postmolds, one set intrusive into the other. If that is so, the earlier mold will contain debris, as will the later intrusive hole, but the mold associated with the intrusive hole will contain humus capped by gray silty clay. Similar arguments can be

made for the remaining conjectural posts. Posthole/postmolds ③, ④, and ⑤ should be similar to those at A, B, C, and D, while posthole/postmold ⑥ should be most like those at H and I (Figure 18).
